Flood Control Project Maintenance
2019 Structure Summary Report
Overall Unit and Item Ratings

Plumas County

North Fork Feather River Diversion Channel Drop Structure No. 1

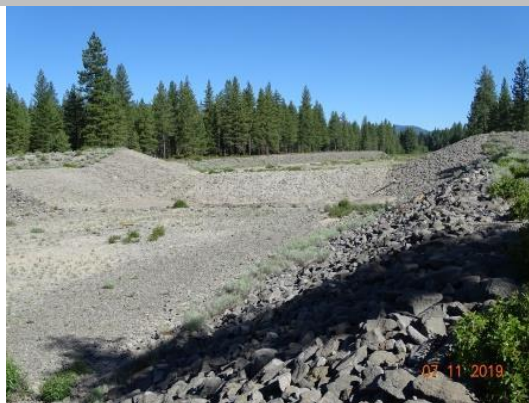
Photo 1 of 2 : ST_2019_NA0015_57_23_20190716_00008.jpg

| Inspector Comments: The structure and channel are in good condition, clear of debris and flows are not impeded, 2019. | | | | | |

View looking upstream from Drop Structure 1, 2019.

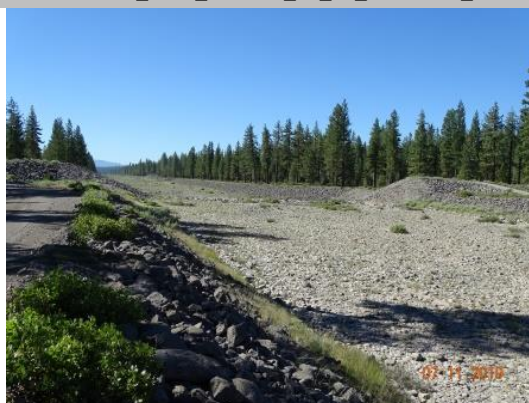
Photo 2 of 2 : ST_2019_NA0015_57_23_20190716_00007.jpg

View looking downstream from Drop Structure 1, 2019.

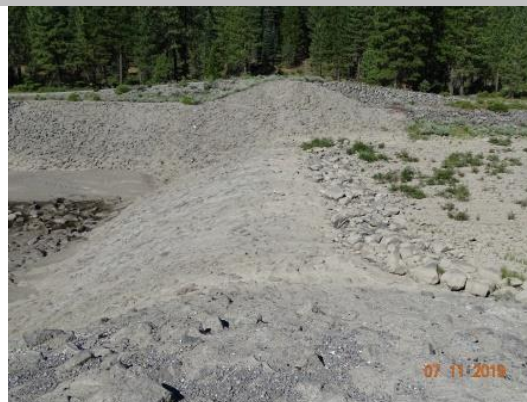
Photo 1 of 1 : ST_2019_NA0015_57_4_20190716_00006.jpg

| Inspector Comments: Existing riprap protection is properly maintained. | | | | | |

View looking across the drop structure from the left bank at the well maintained concreted revetment, 2019.

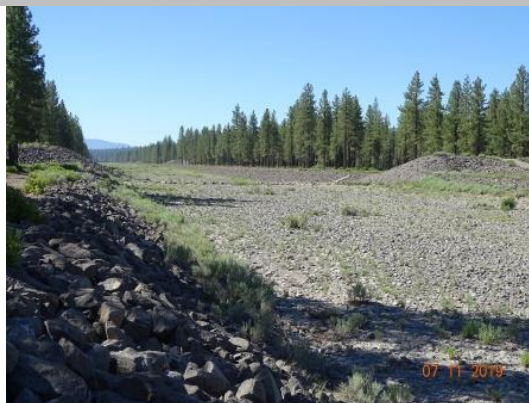
Photo 1 of 2 : ST_2019_NA0015_58_23_20190716_00006.jpg

| Inspector Comments: The structure and channel are in good condition, clear of debris, and the flows are not impeded, 2019. | | | | | |

View of Drop Structure 2 looking downstream, 2019.

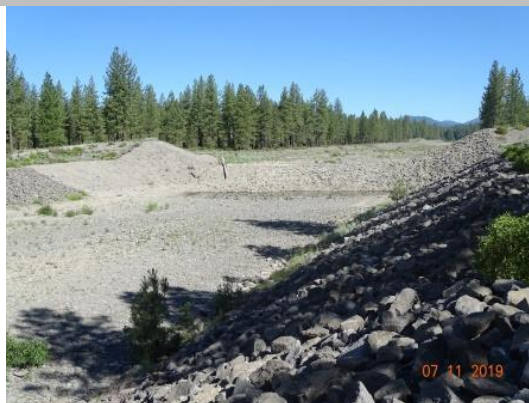
Photo 2 of 2 : ST_2019_NA0015_58_23_20190716_00007.jpg

View of Drop Structure 2 looking upstream, 2019.

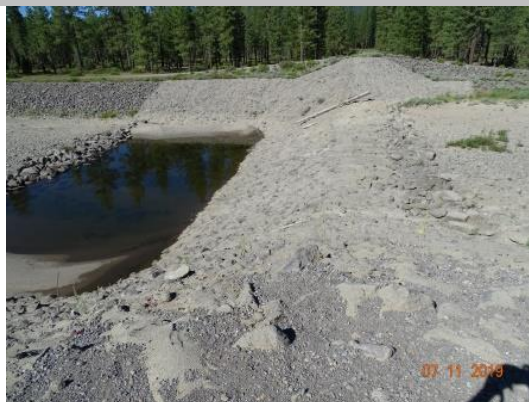
Photo 1 of 1 : ST_2019_NA0015_58_4_20190716_00008.jpg

| Inspector Comments: Existing concreted revetment protection is properly maintained. | | | | | | |

View looking across the drop structure from the left bank at the well maintained concreted revetment, 2019.

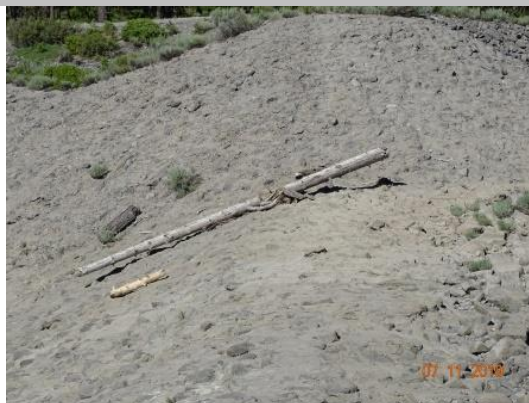
Photo 1 of 1 : ST_2019_NA0015_58_5_20190716_00009.jpg

| Inspector Comments: There is one log on the drop structure that needs to be removed, but the flow is not impeded, 2019. | | | | | |

View looking from left bank across the drop structure at a log that needs to be removed, 2019.

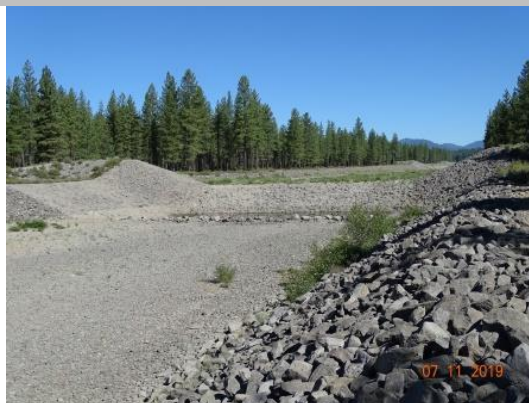
Photo 1 of 2 : ST_2019_NA0015_59_23_20190716_00005.jpg

| Inspector Comments: The structure and channel are in good condition, clear of debris, and the flows are not impeded, 2019. | | | | | |

View looking upstream at Drop Structure 3, 2019.

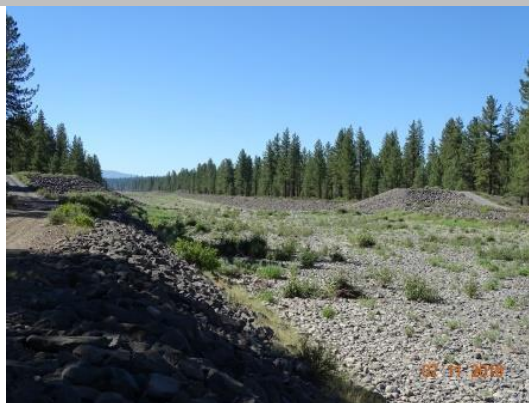
Photo 2 of 2 : ST_2019_NA0015_59_23_20190716_00004.jpg

View looking downstream at Drop Structure 3, 2019.

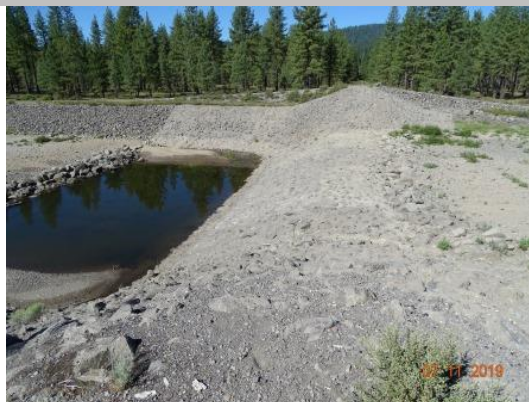
Photo 1 of 1 : ST_2019_NA0015_59_4_20190716_00006.jpg

| Inspector Comments: Existing concrete riprap protection is properly maintained, 2019. | | | | | |

View looking across the drop structure from the left bank at the well maintained concreted revetment, 2019.

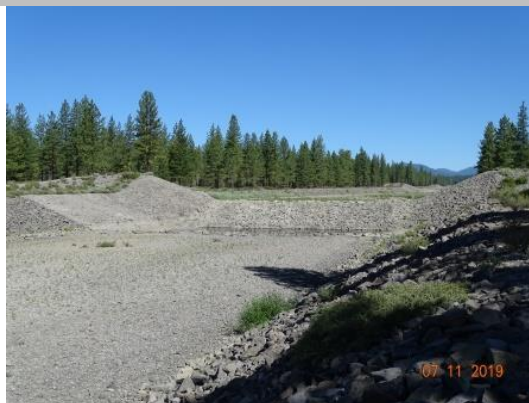
Photo 1 of 2 : ST_2019_NA0015_60_23_20190716_00006.jpg

| Inspector Comments: The structure and channel are in good condition, clear of debris, and the flows are not impeded, 2019. | | | | | |

View looking upstream at Drop Structure 4, 2019.

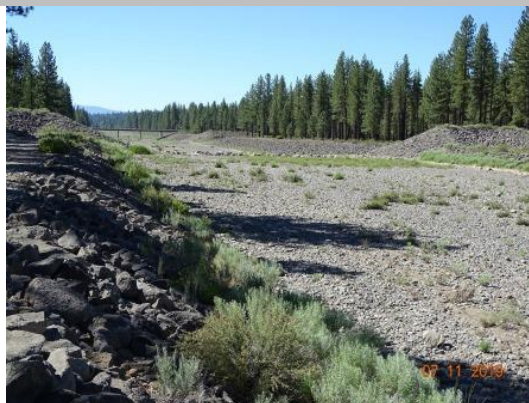
Photo 2 of 2 : ST_2019_NA0015_60_23_20190716_00005.jpg

View looking downstream at Drop Structure 4, 2019.

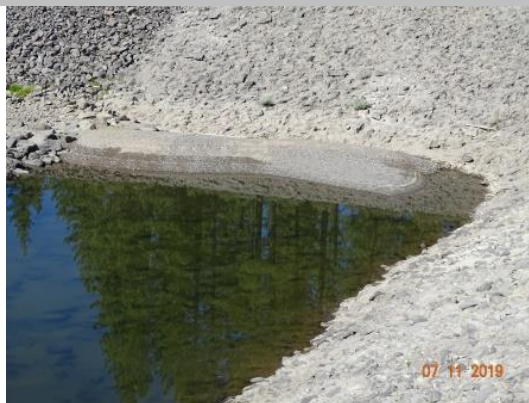
Photo 1 of 1 : ST_2019_NA0015_60_2_20190716_00007.jpg

| Inspector Comments: There is no shoaling but the start of small a sedimentation deposit ispresent, however this should not impede flows, 2019. | | | | | |

View of the right and left side of the channel have a small build up of sedimentation, 2019.

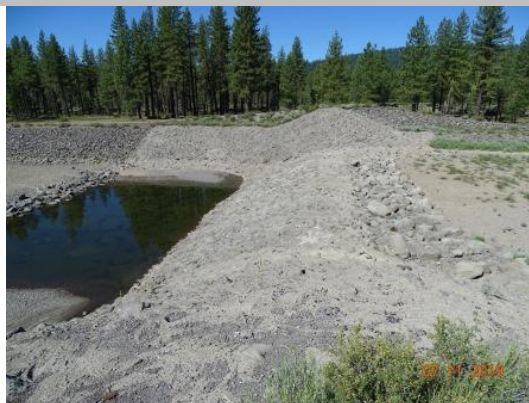
Photo 1 of 1 : ST_2019_NA0015_60_4_20190716_00008.jpg

| Inspector Comments: Existing concreted riprap protection is properly maintained. | | | | | |

View looking across the drop structure from the left bank at the well maintained concreted revetment, 2019.

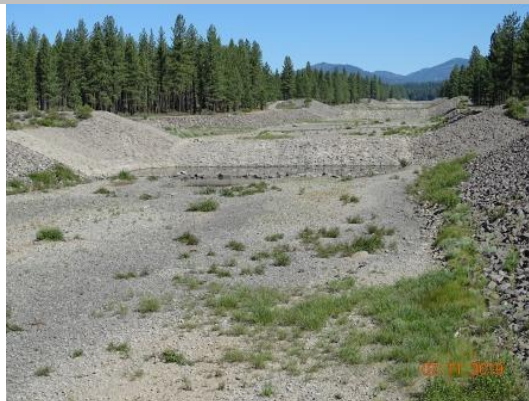
Photo 1 of 2 : ST_2019_NA0015_61_23_20190716_00005.jpg

| Inspector Comments: The structure and channel are in good condition, clear of debris, and the flows are not impeded, 2019. | | | | | |

View looking upstream at Drop Structure 5, 2019.

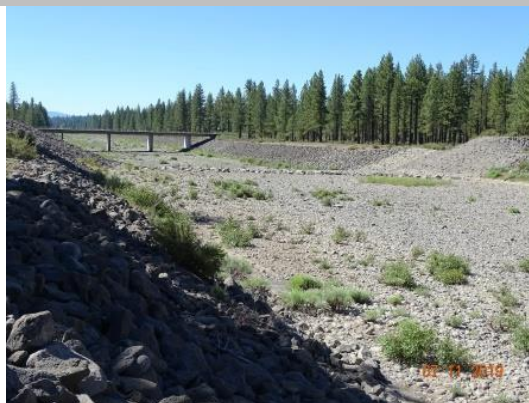
Photo 2 of 2 : ST_2019_NA0015_61_23_20190716_00004.jpg

View looking downstream at Drop Structure 5, 2019.

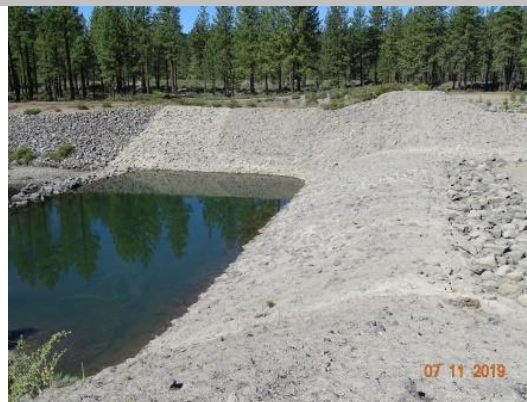
Photo 1 of 1 : ST_2019_NA0015_61_4_20190716_00006.jpg

| Inspector Comments: Existing concreted riprap protection is properly maintained. | | | | | |

View looking across the drop structure from the left bank at the well maintained concreted revetment, 2019.

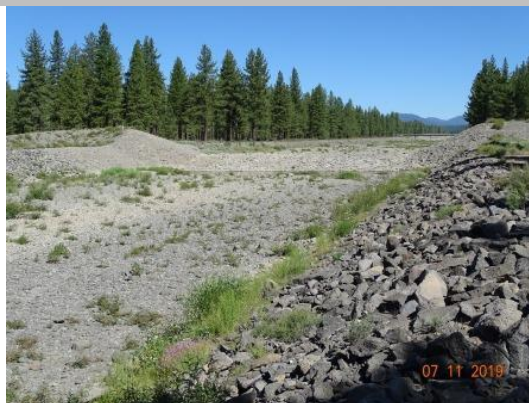
Photo 1 of 2 : ST_2019_NA0015_62_23_20190716_00005.jpg

| Inspector Comments: The structure and channel are in good condition, clear of debris, and the flows are not impeded, 2019. | | | | | |

View looking upstream at Drop Structure 6, 2019.

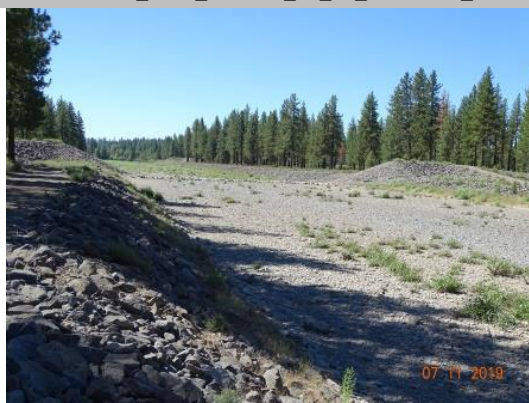
Photo 2 of 2 : ST_2019_NA0015_62_23_20190716_00004.jpg

View looking downstream at Drop Structure 6, 2019.

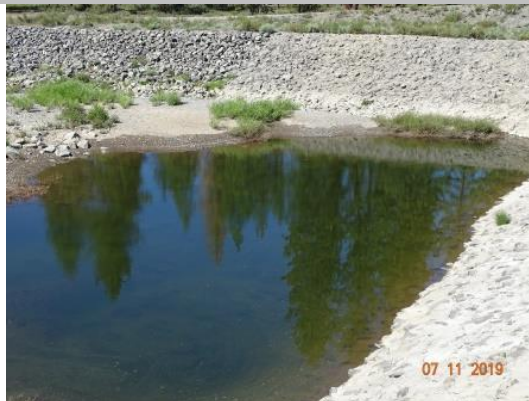
Photo 1 of 1 : ST_2019_NA0015_62_2_20190716_00006.jpg

| Inspector Comments: There is no shoaling but minimal sedimentation is present, 2019. | | | | | |

View of the minimal sedimentation that is building up on left and right banks, the flow is not impeded, 2019.

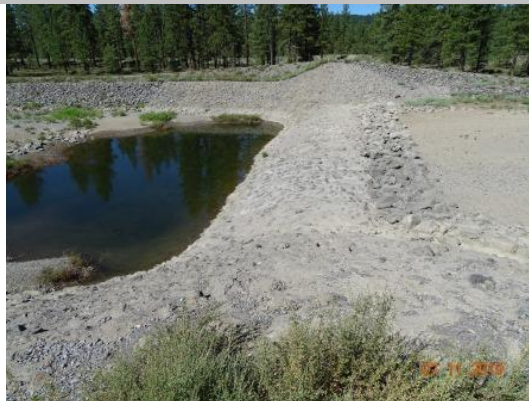
Photo 1 of 1 : ST_2019_NA0015_62_4_20190716_00007.jpg

| Inspector Comments: Existing concrete riprap protection is properly maintained. | | | | | |

View looking across the drop structure from the left bank at the well maintained concreted revetment, 2019.

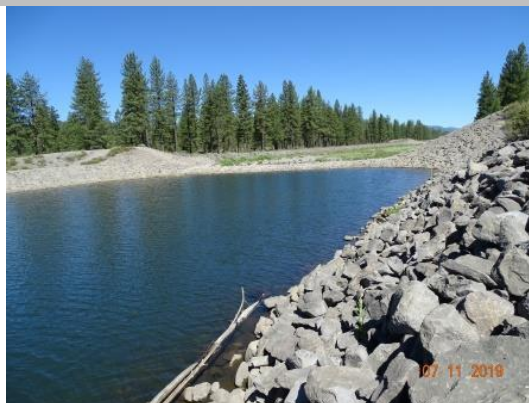
Photo 1 of 2 : ST_2019_NA0015_63_23_20190716_00006.jpg

| Inspector Comments: The structure and channel are in good condition, clear of debris, and the flows are not impeded, 2019. | | | | | |

View looking upstream at Drop Structure 7, 2019.

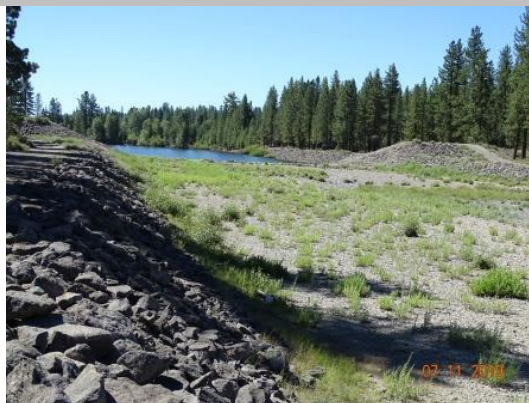
Photo 2 of 2 : ST_2019_NA0015_63_23_20190716_00005.jpg

View looking downstream at Drop Structure 7, 2019.

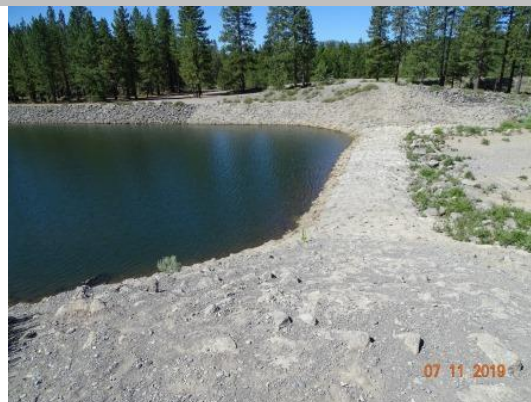
Photo 1 of 1 : ST_2019_NA0015_63_4_20190716_00007.jpg

| Inspector Comments: Existing concrete riprap protection is properly maintained. | | | | | | |

View looking across the drop structure from the left bank at the well maintained concreted revetment, 2019.

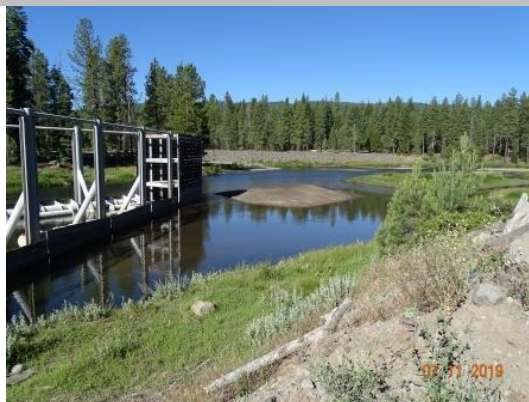
Photo 1 of 3 : ST_2019_NA0015_37_2_20190718_00023.jpg

View of the inlet structure and how the sedimentation builds up in front of the structure, 2019.

| Inspector Comments: Remove the sediment as needed, and keep the inlet structure and fish ladder clear of sedimentation and debris, 2019. | | | | | |

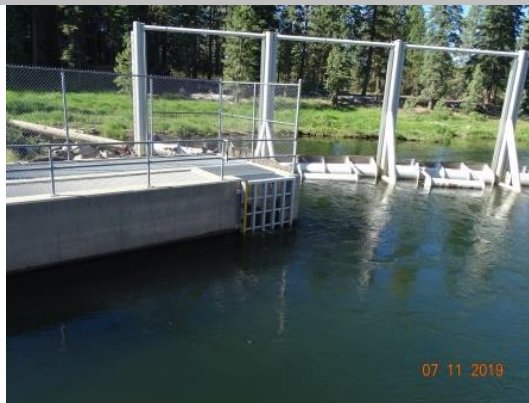
Photo 2 of 3 : ST_2019_NA0015_37_2_20190718_00022.jpg

View of the fish ladder intake, no sedimentation observed, 2019.

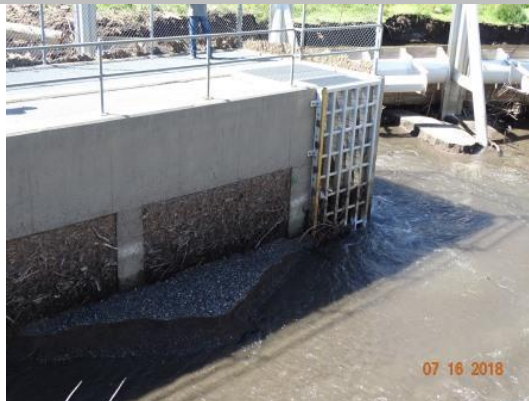
Photo 3 of 3 : ST_2019_NA0015_37_2_20190701_00001.jpg

View of the build up of sedimentation and debris at the fish ladder intake, 2018.

| Inspector Comments: Remove the sediment as needed, and keep the inlet structure and fish ladder clear of sedimentation and debris, 2019. | | | | | | |

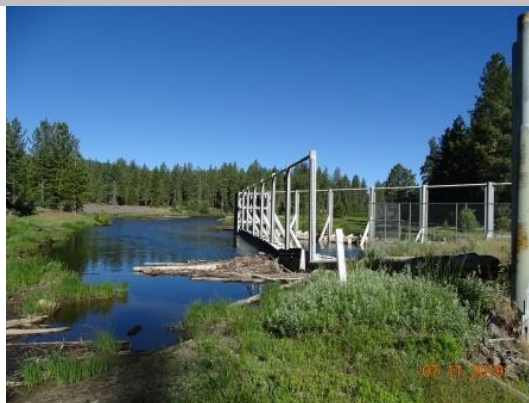
Photo 1 of 1 : ST_2019_NA0015_37_5_20190718_00024.jpg

View of the debris at the diversion intake structure south side, most of the debris was removed, but the District could not reach it all due to the meandering of the river, 2019.

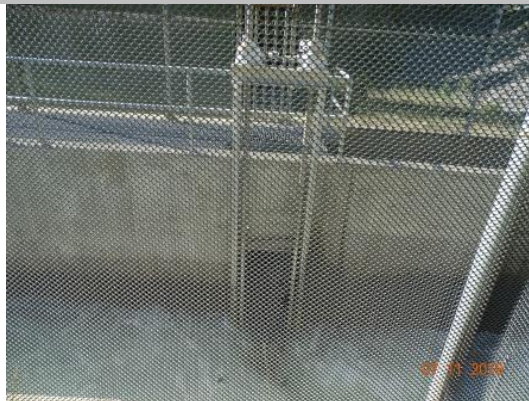
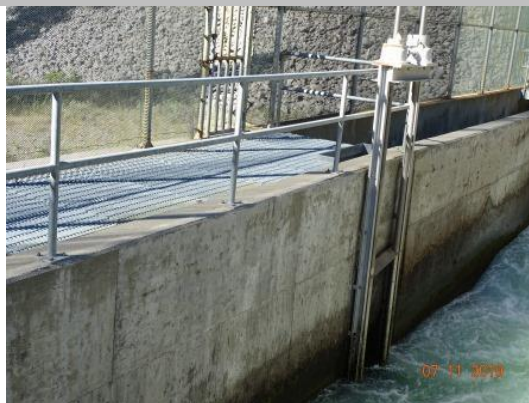
| Inspector Comments: Slide gates are in good working condition, 2019. | | | | | |

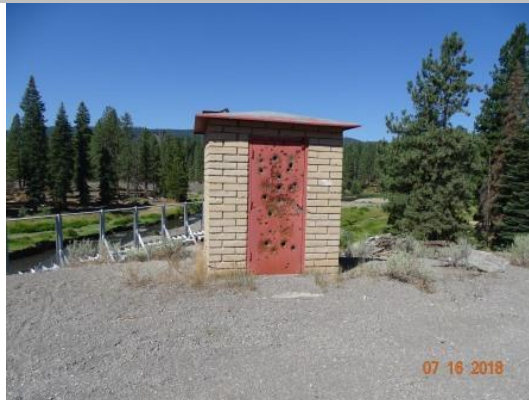
Photo 1 of 1 : ST_2019_NA0015_37_12_20190701_00007.jpg

Gauging house on top of dam, no longer used due to vandalism, 2018.

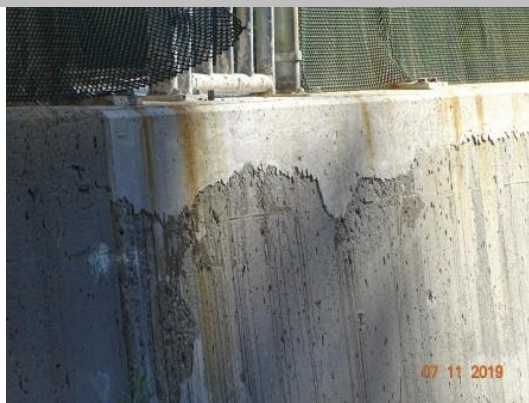
Photo 1 of 1 : ST_2019_NA0015_37_14_20190718_00031.jpg

View of the concrete spalling repair on the south wall of the outfall structure, 2019.
